STRUCTURAL EVALUATION OF THE JAMES K. HAHN CITY HALL EAST BUILDING

Subject: **STRUCTURAL EVALUATION OF THE JAMES K. HAHN CITY HALL EAST-
200 N. MAIN ST. W.O. EXX01002**

INTRODUCTION

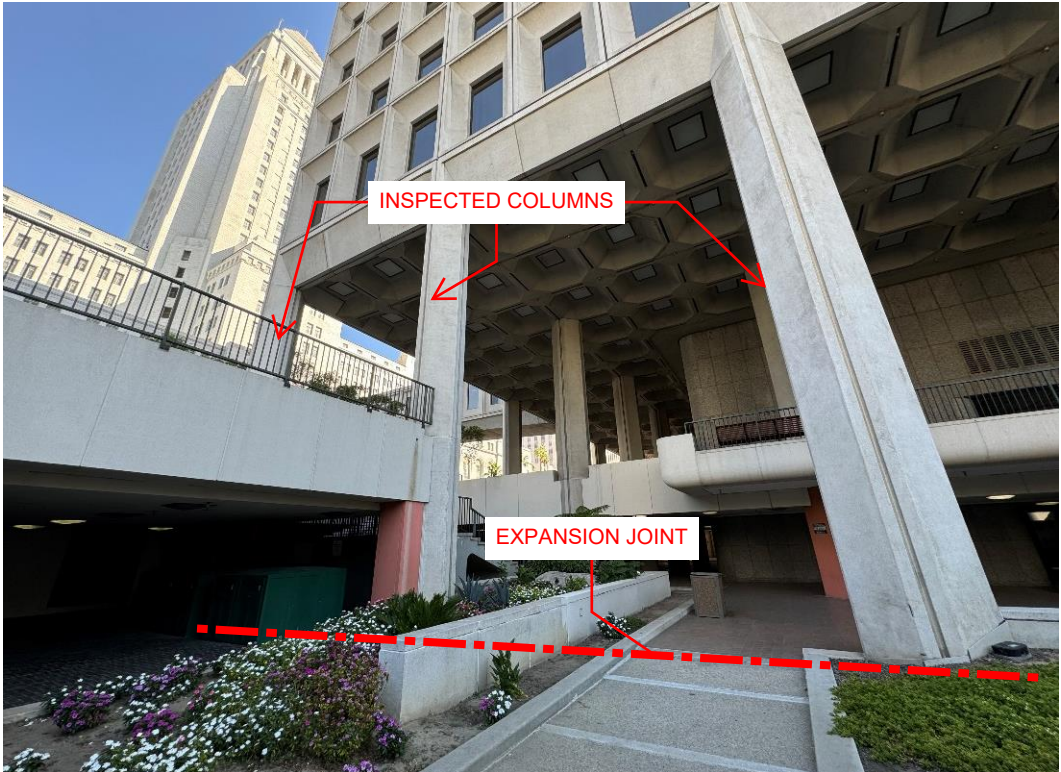
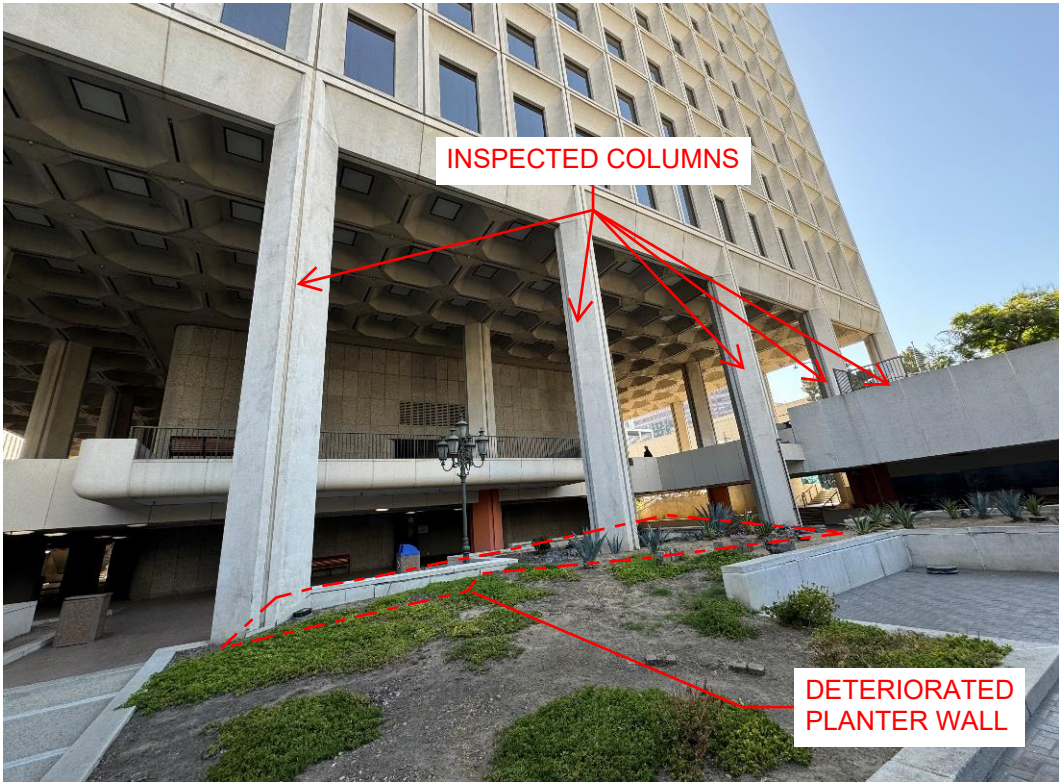
- An expansion joint is located in between the building (edge of columns) and planter area of the open courtyard at the F-1 Level (Photos 4 and 5).
- The waterproofing at the planter wall shows considerable deterioration (Photo 6), due to lack of maintenance.
- The concrete soffit at F-2 level, located beneath and directly adjacent to the expansion joints and waterproofing, shows deterioration and spalling concrete (Photo 12).

Photo 4: Columns Above Ground

Photo 5: Columns Above Ground

A nondestructive testing (NDT) should be performed to determine the extent of corrosion in the concrete columns and concrete slabs. The deteriorated expansion joint and waterproofing at the open courtyard and behind the planter walls need to be replaced and regularly maintained.

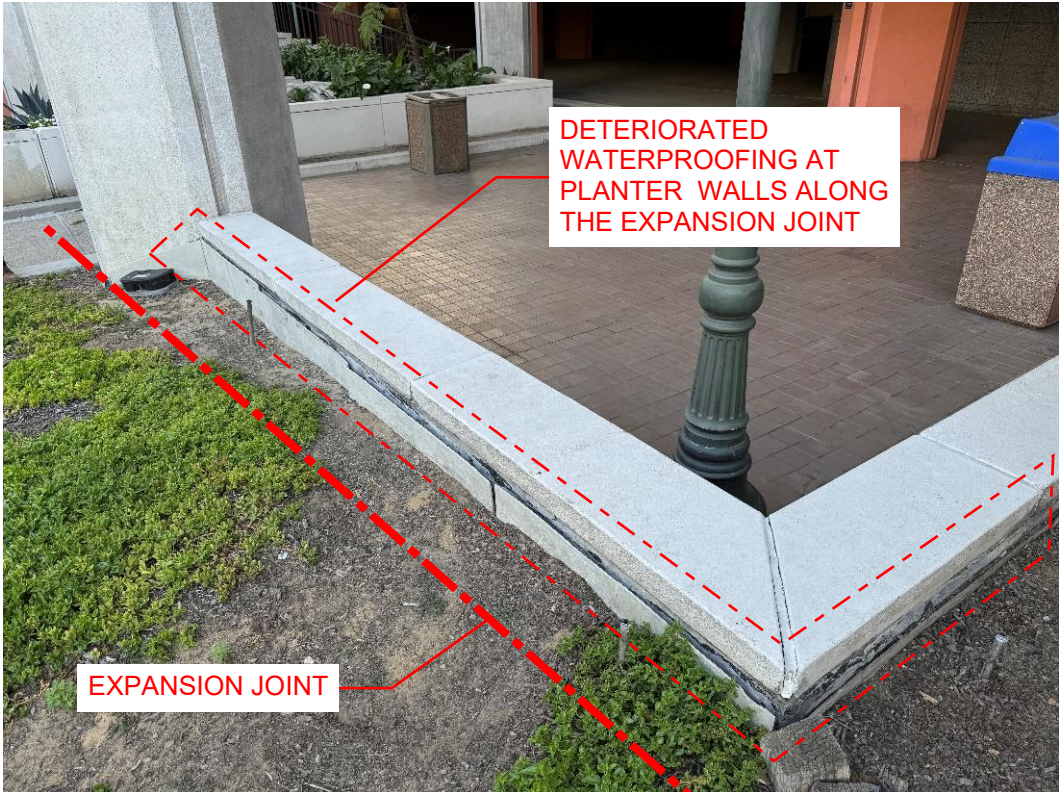
- The soffit at the F-2 basement parking shows considerable deterioration and spalling. Rebars were exposed and are corroded. This appears to be the result of water ingress in the basement from deteriorated expansion joint and planter waterproofing (Photos 6, 7 and 8).
- A temporary collection system has been installed to collect the loose and broken concrete pieces from falling on the vehicles parked under the affected area (Photo 9).
- Efflorescence was observed at several locations (Photo 11).

Photo 6: Deteriorated Waterproofing at Planter Walls

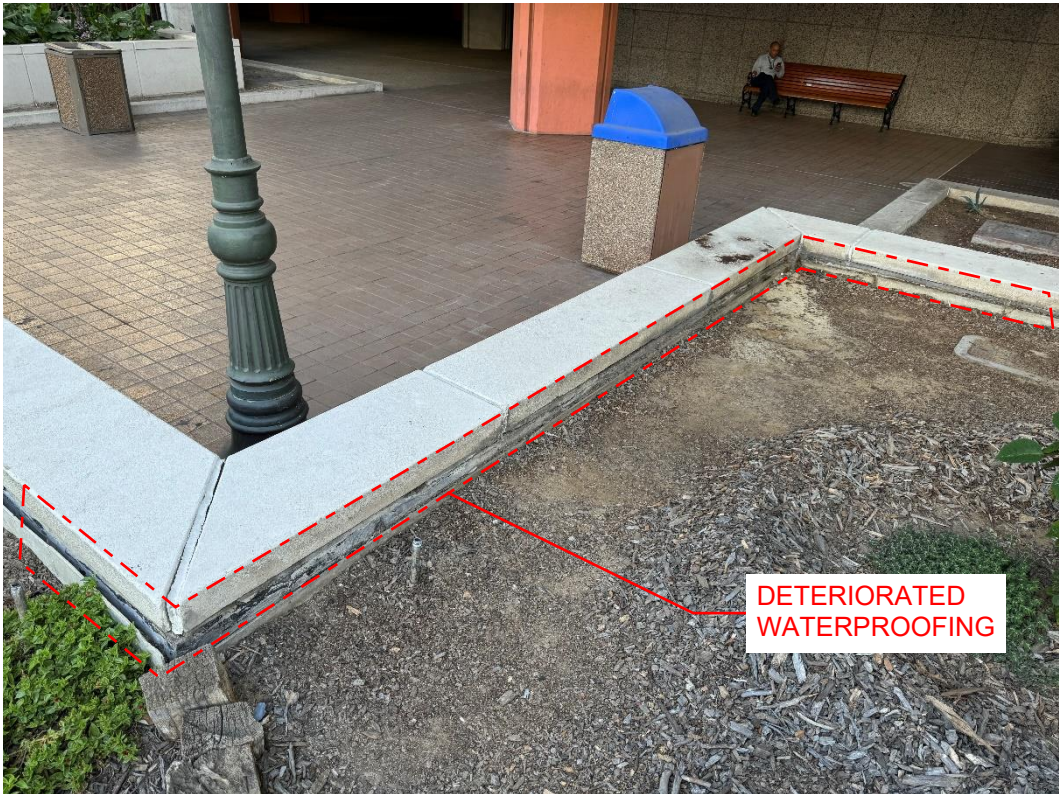
Photo 7: Deteriorated Waterproofing at Planter Walls

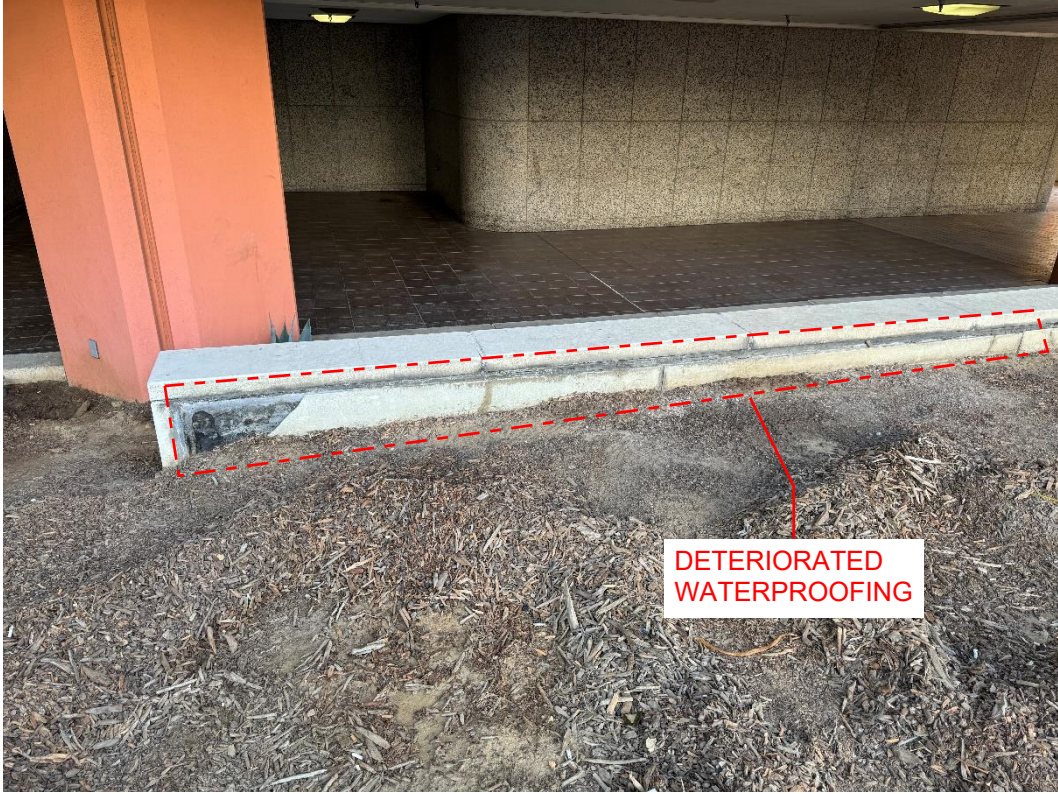
DETERIORATED
WATERPROOFING

Photo 8: Deteriorated Waterproofing at Planter Walls

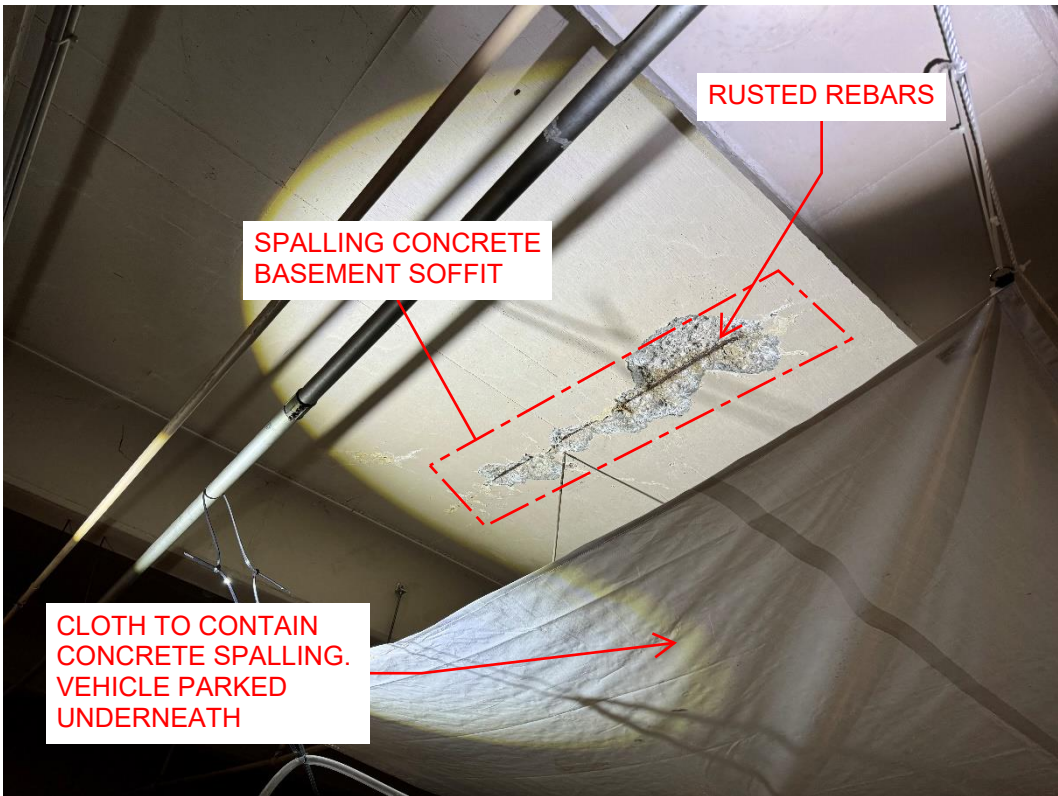
RUSTED REBARS

SPALLING CONCRETE
BASEMENT SOFFIT

CLOTH TO CONTAIN
CONCRETE SPALLING.
VEHICLE PARKED
UNDERNEATH

Photo 9: Spalling Concrete Soffit

Cordon off access to the areas of concern (photos 9 and 12). Do not allow vehicular parking or pedestrian traffic in this area until it is repaired/retrofitted. Limit access to construction, engineering and inspection personnel only.

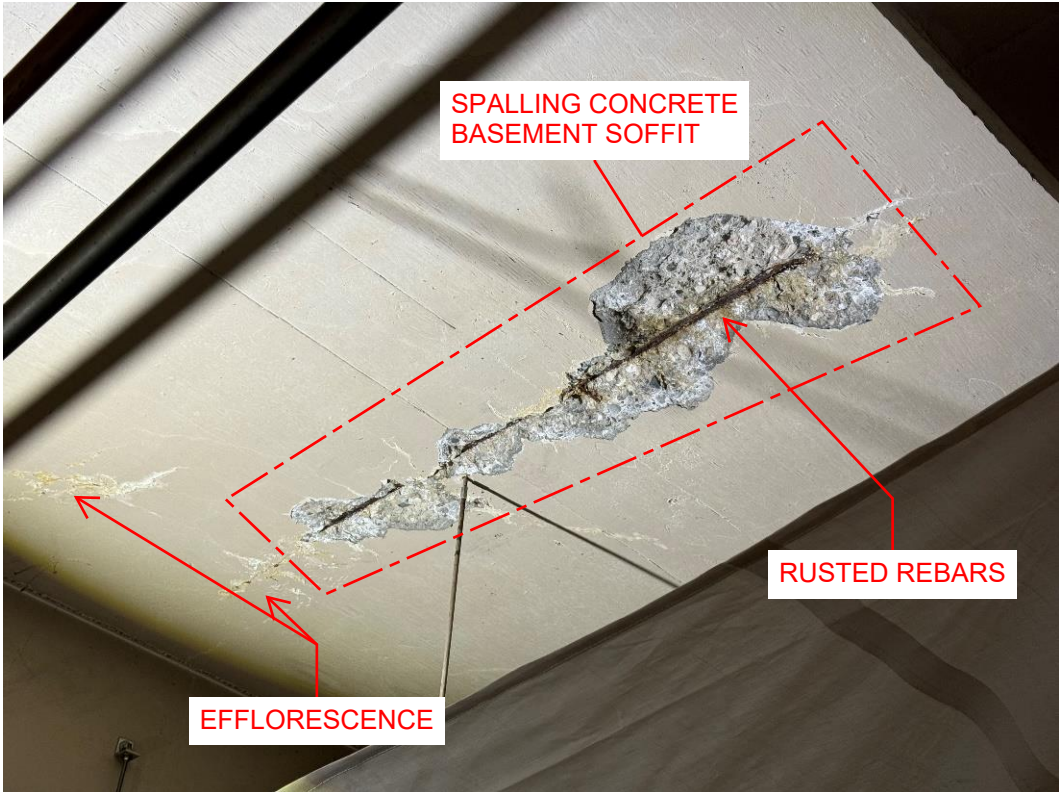
Photo 10: Spalling Concrete Ceiling

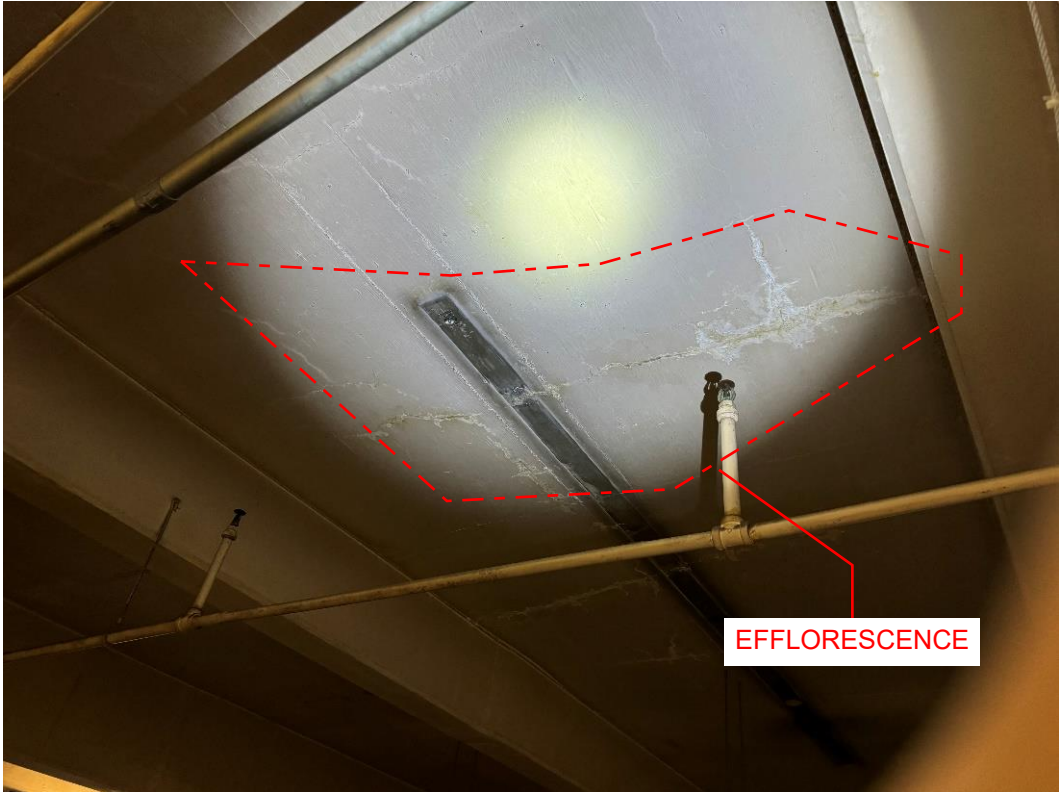
Photo 11: Efflorescence in Soffit Slab

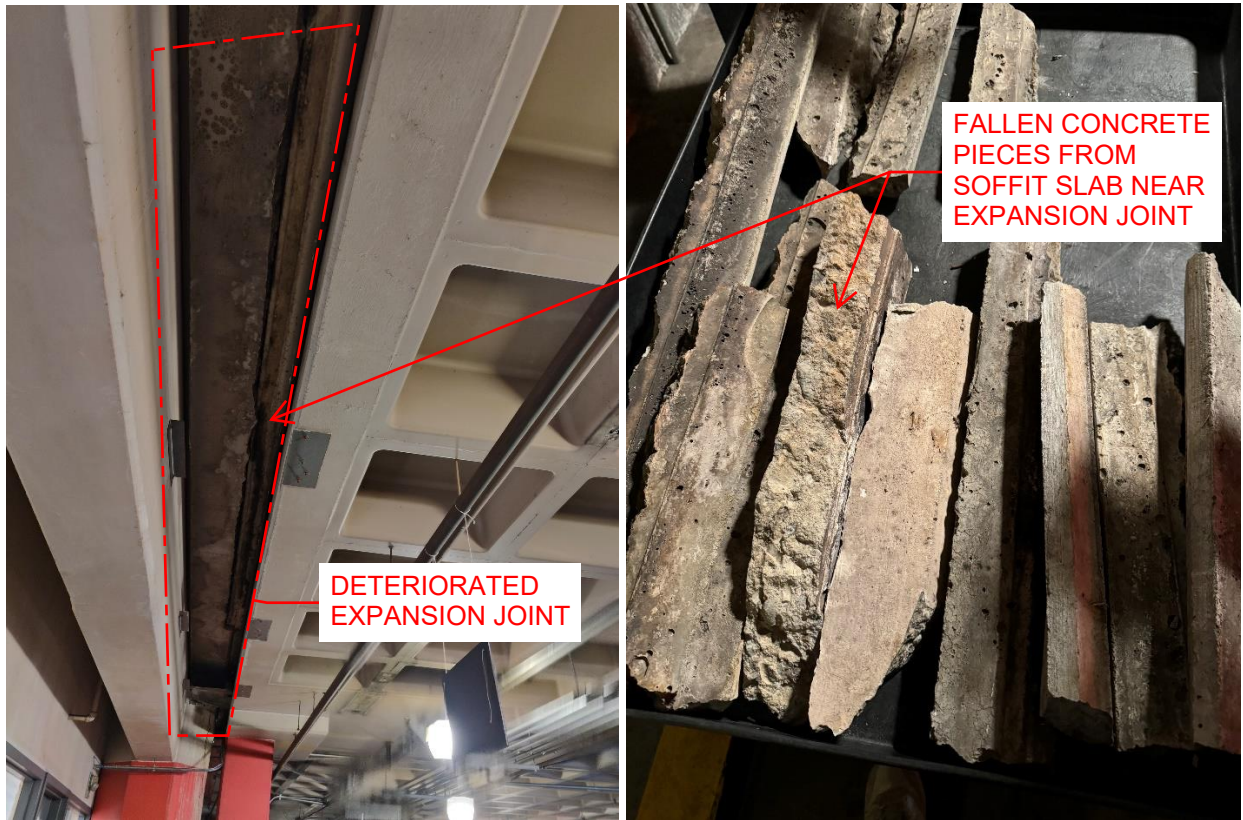
Photo 12: Spalling Concrete at Expansion Joint

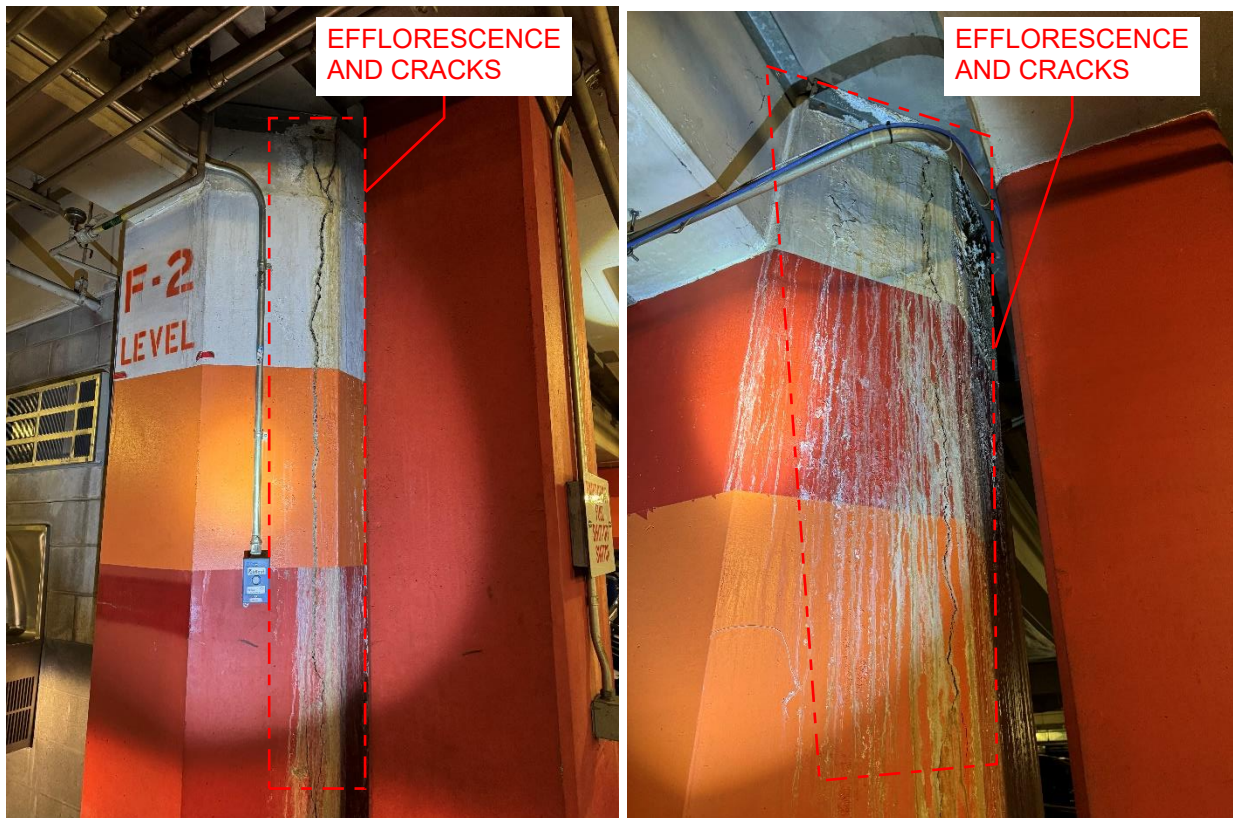
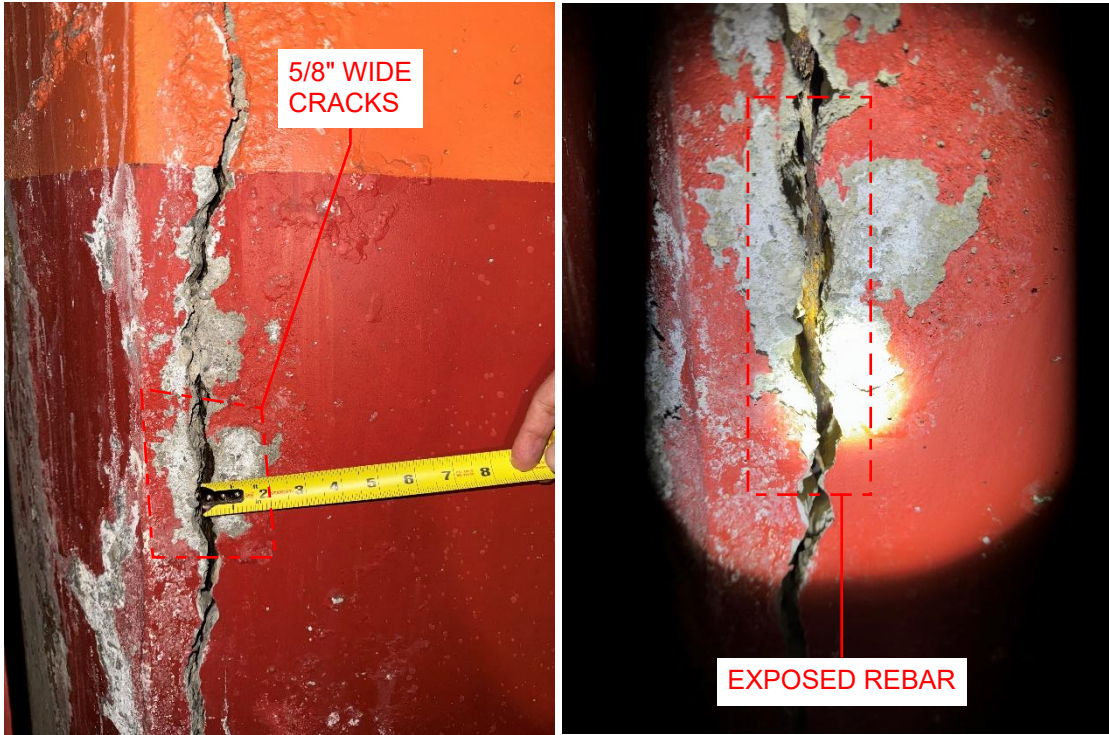
- The columns at F-2 level have significant cracks (up to 5/8" wide and spanning entire height of the column), efflorescence, spalling and corrosion of the steel rebars (Photos 13 and 14). This condition is observed at all seven columns (A to G) on the southwest side of the building.
- Honeycombing was also observed on the concrete columns at the F-2 level (Photo 15).

Photo 13: Column Corrosion Cracks and Efflorescence

Photo 14: Column Corrosion Cracks

SED recommends the following non-destructive tests to assess the condition of existing concrete and rebars:

1. Ultrasound Pulse Velocity (UPV) Test in accordance with ASTM C597
2. Corrosion Half-Cell Potential Survey in accordance with ASTM C876

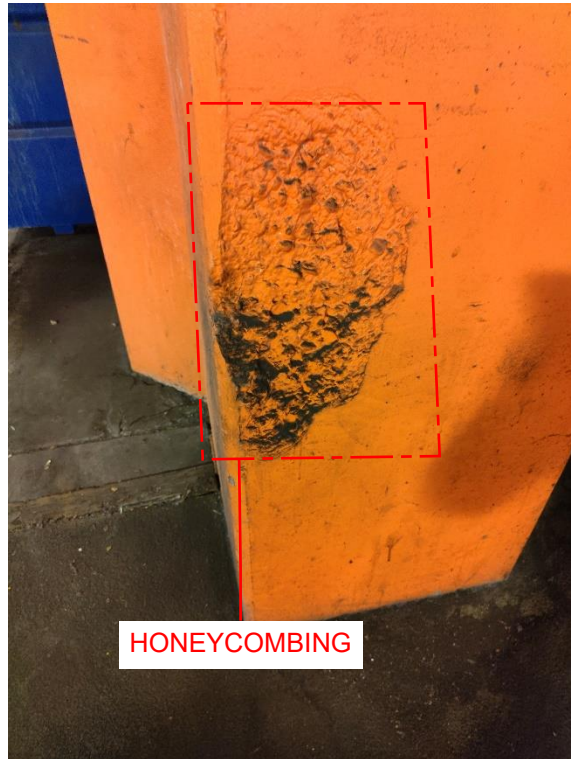
Photo 15: Honeycombing at F-2 Column

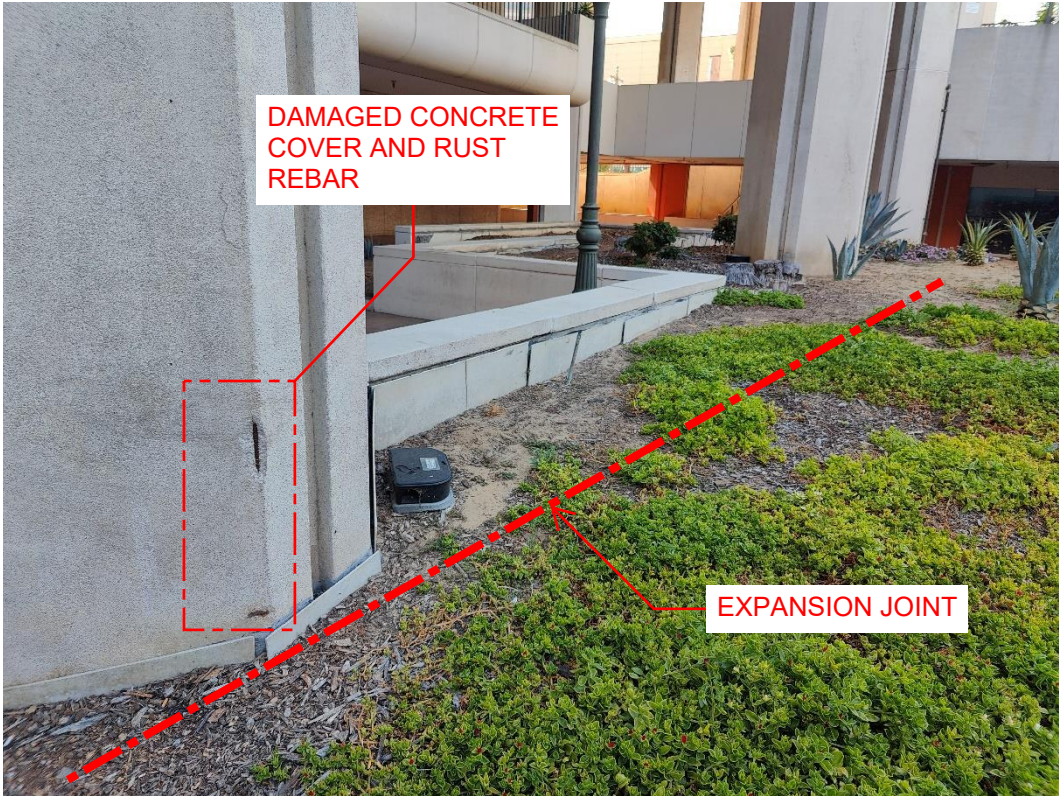
Photo 16: Damaged Concrete Cover

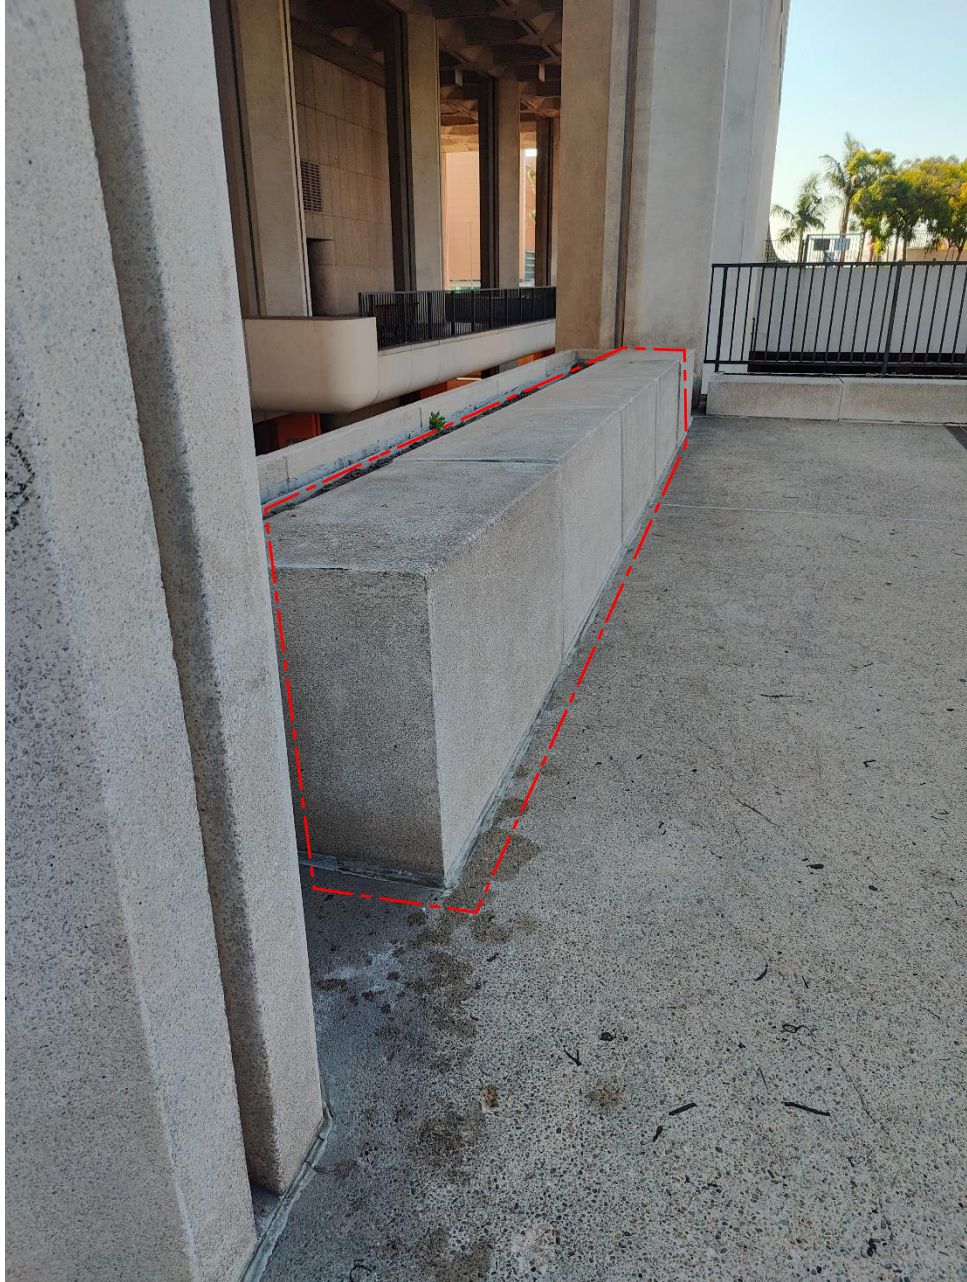
- A noticeable warping was observed in the parapet wall spanning between columns F and G at the street level along main street. This might be a result of foundation settlement or inadequate design/construction (Photo 17).
- No cracks or deterioration was observed on this parapet wall.

Photo 17: Contorted Parapet/Planter Wall
