Subject: **CITYWIDE YARDS AND SHOPS MASTER PLAN STUDY: STATUS UPDATE
AND PROPOSED NEXT PHASE OF IMPLEMENTATION**

The Citywide Maintenance Yard Facilities Assessment, Optimization, and Consolidation: Phase 1 – Task A
South Los Angeles, Civic Center, and Surrounding Communities Project

May 29, 2024

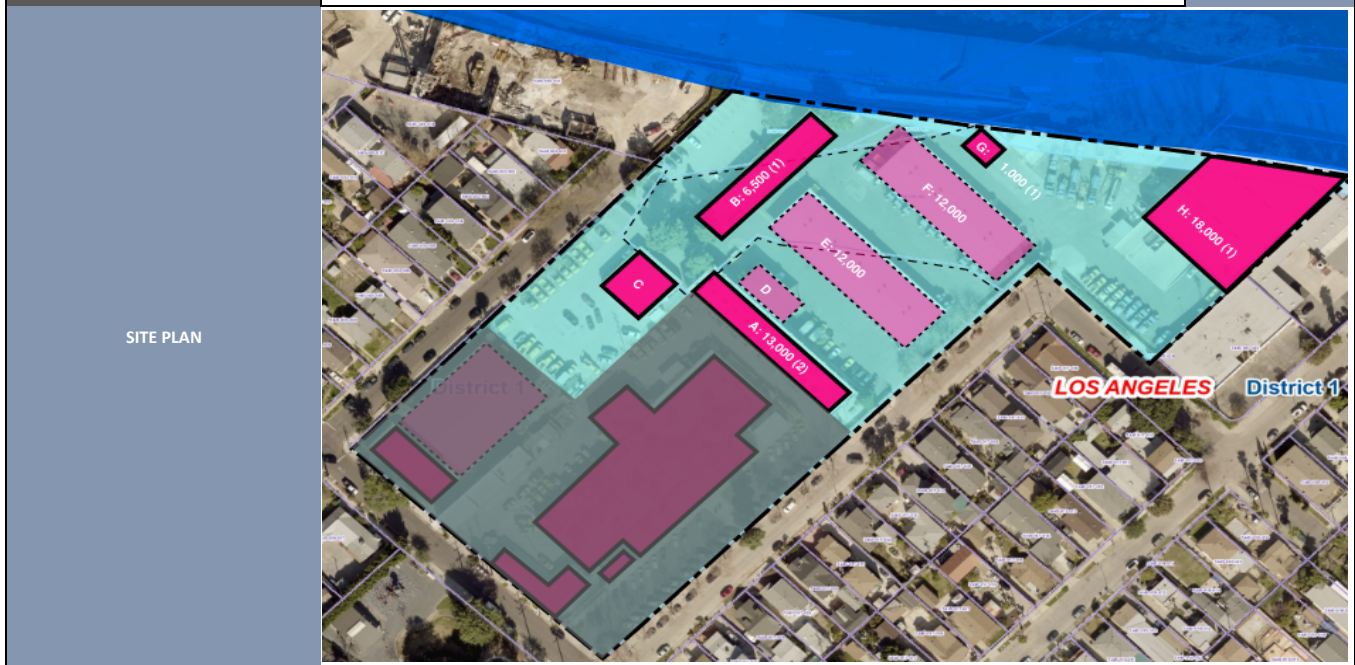
NAME	G1Y5 NORTH DISTRICT SEWER MAINTENANCE YARD	
ADDRESS	2335 Dorris Place

COUNCIL DISTRICT	13
ZONING	PF
LOT ACREAGE	4.36
BUILDING AREA (SF)	37,500
LEAD DEPARTMENTS	LASAN
STAFF COUNT	220

KEY	MARK	CATEGORY	DEFICIENCY
Fire Life Safety	FLS	High	YES
Americans with Disabilities Act	ADA	High	YES
Security Issues	SEC	High	YES
General Equity and Social Inclusion	GESI	Medium	YES
General Systems Issues	SYS	Medium	YES
Efficiency Issues	EFF	Low	YES
Space Limitations	SPC	Low	YES
Green Investment	GRI	Low	YES

FUNDING	ITEM	DESCRIPTION	ESTIMATED COST
PRIORITY SHORT TERM	1	Provide expanded women's restrooms and lockers		\$90,911
	2	Provide hardened security perimeter and improved camera coverage		\$1,710,726
	3	Repair envelope in Building A (roof repairs and possible wall flashing upgrades)		\$147,645
	4	Provide new training trailers		\$312,722
LONG TERM	5	Relocate LASAN program to G1Y8 San Fernando Road Facility		\$59,038,711
MASTER PLAN NOTES	<p>Overview:</p> <p>The site is cohabitated by GSD Testing Lab and LASAN North District Sewer Maintenance Yard. The site is located within a residential neighborhood and across from an elementary school. The site lacks adequate clearances for LASAN's vehicles both for maneuvering in, out, and through the site but also the covered parking areas and maintenance areas a structurally limited for larger vehicles such as vactors.</p>

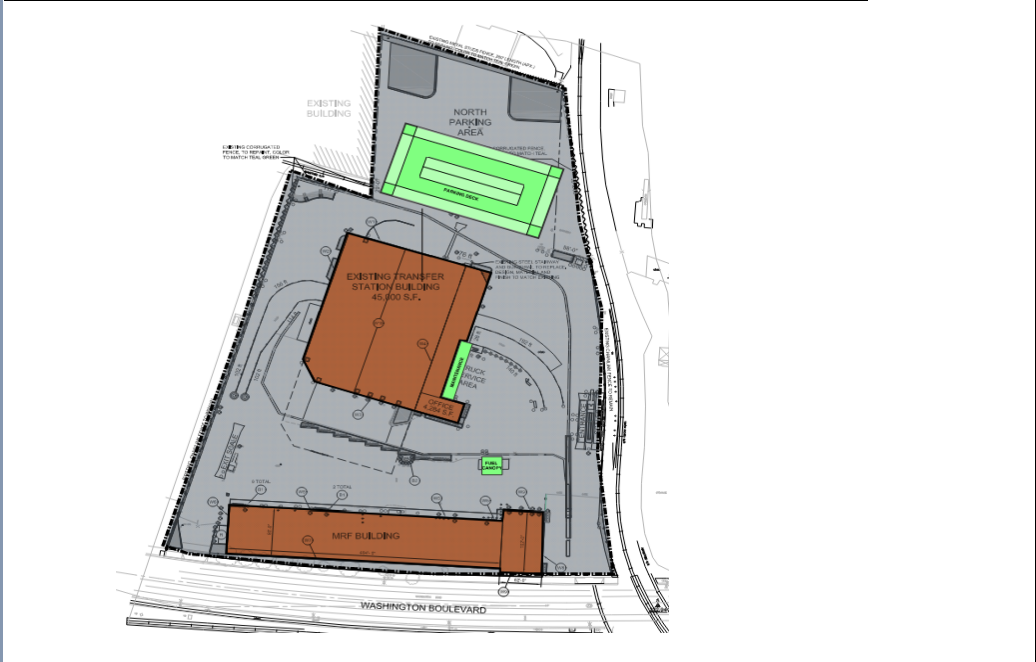
MASTER PLAN

FUNDING	ITEM	DESCRIPTION	ESTIMATED COST
PRIORITY SHORT TERM	1	Provide hardened security perimeter and improved camera coverage	\$1,058,853
	2	Provide canopy over fuel pumps	\$169,316
	3	Provide canopy over wash area	\$169,316
	4	Provide upgraded mechanical systems	\$216,315
LONG TERM	5	Provide structured parking deck to alleviate mixing of private and revenue vehicles	\$5,934,073
	6	Extend the maintenance to right-size the maintenance bays	\$452,086

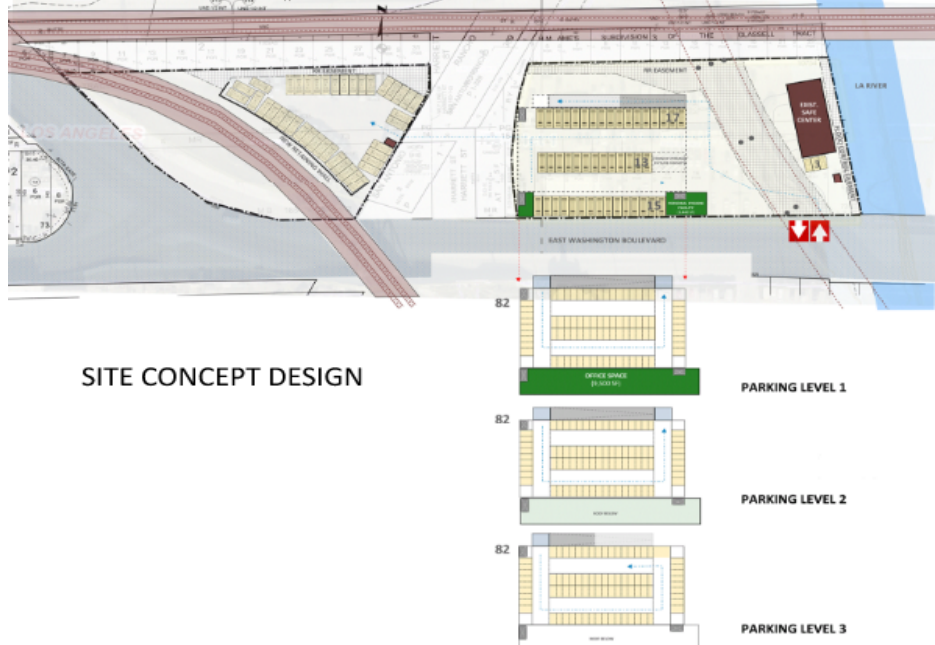
NAME	G3Y12 SOUTH CENTRAL OFFICE BUILDING			
ADDRESS	2649 E Washington Boulevard			
<p>MASTER PLAN NOTES</p>

<p style="text-align: center;">SITE CONCEPT DESIGN</p>			
	<p>FUNDING</p>	<p>ITEM</p>	<p>DESCRIPTION</p>	<p>ESTIMATED COST</p>
<p>PRIORITY SHORT TERM</p>	<p>1</p>	<p>Security upgrades to site--fencing, cameras, etc.</p>	<p>\$962,146</p>	
	<p>2</p>	<p>Mechanical system upgades</p>	<p>\$184,437</p>	
	<p>3</p>	<p>Provide rough wash canopy with clarifier</p>	<p>\$1,025,644</p>	
<p>LONG TERM</p>	<p>4</p>	<p>Larger permanent faciliy with additional parking required</p>	<p>\$18,483,760</p>	
<p>MASTER PLAN NOTES</p>	<p>1. Short term improvements to HVAC systems and general site security</p> <p>2. Due to the temporary and inefficient nature of the LSD trailers, unregulated use of conex boxes, space limitations, etc. A permanent building with structured parking is a preferred long-term solution</p> <p>3. The adjoining S.A.F.E Collection center expressed no concerns over their operation so no improvements are recommended at this time.</p> <p><i>Note: Short term improvements would be redudant to a long term site renovation.</i></p>

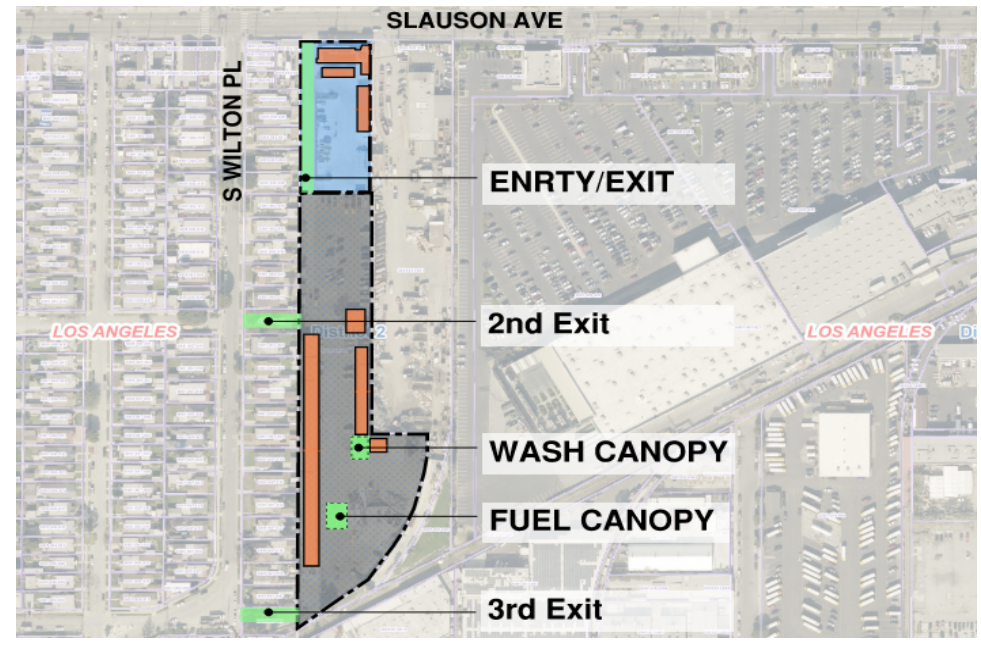
MASTER PLAN

FUNDING	PRIORITY	DESCRIPTION	ESTIMATED COST
PRIORITY SHORT TERM	1	Utilize drive to the North as primary entry exit	\$85,189
	2	Renovate restrooms/lockers/showers to provide adequate, equal, accessible facilities	\$112,590
	3	Provide hardened security with cameras, entry alarms, etc	\$462,912
	4	Upgrade site lighting	\$219,609
	5	Repair roof leaks in office and enclosed storage building	\$150,313
	6	Provide covered rough wash rack	\$154,235
	7	Provide fuel canopy	\$154,235
	8	Provide new compressed air system	\$22,226
	9	Convert exercise room to crew meeting space	\$153,911
LONG TERM	10	Repave Site	\$810,701

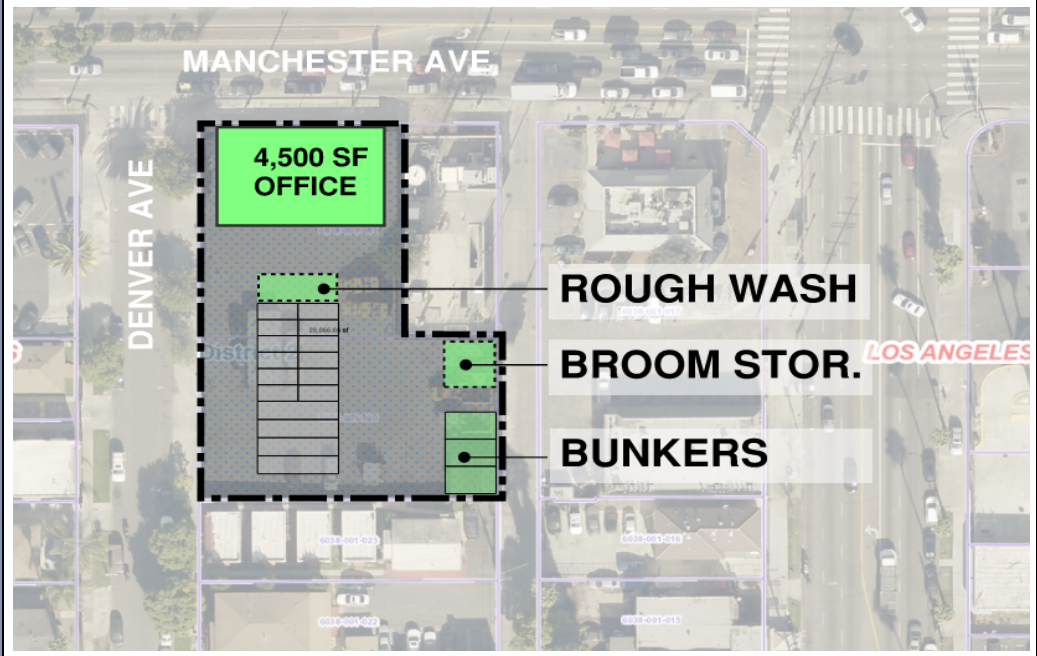
MASTER PLAN

FUNDING	PRIORITY	DESCRIPTION	ESTIMATED COST
PRIORITY SHORT TERM	1	Convert men's restrooms, showers, and lockers to unisex	\$83,513
	2	Security upgrades to site--fencing, cameras, etc	\$333,728
LONG TERM	3	Reconstructed site	\$4,183,804

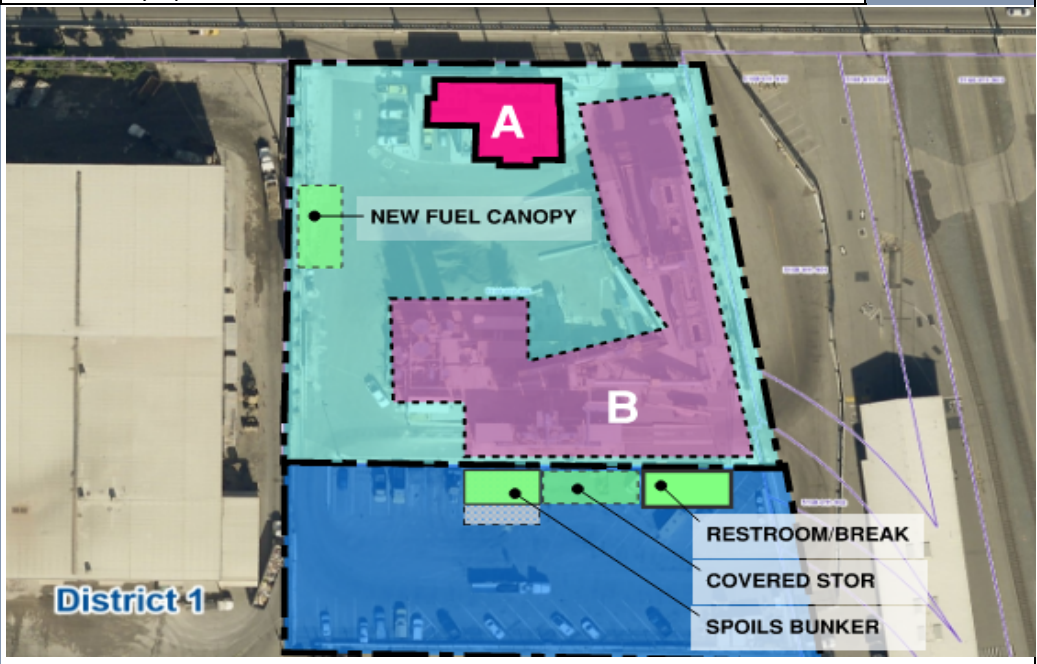
NAME	G3Y9 ASPHALT PLANT #1			
ADDRESS	2484 East Olympic Boulevard			
MASTER PLAN

FUNDING	PRIORITY	DESCRIPTION	ESTIMATED COST
PRIORITY SHORT TERM	1	Repair roof and/or wall leaks in Main Administration Building	\$106,178	
	2	Provide adequate lighting on Asphalt Equipment	\$39,330	
	3	Provide catwalk safety gangways on Asphalt Equipment	\$764,383	
	4	Provide Driver's Ammenities Trailer (1,800 SF: bathrooms, showers, breakrooms)	\$323,914	
	5	Provide canopy over fuel pumps	\$154,915	
LONG TERM	6	Acquire southern parcel (1.1 acres)	\$7,887,740	
	7	Provide asphalt bunker with concrete apron (50'x50')	\$243,852	
	8	Provide covered laydown structure (2,000 SF)	\$169,506	
MASTER PLAN NOTES	<p>Overview: The site's primary function is asphalt production for City's roadways. The site was part of a 2019 modernization effort and the main building is relatively new despite profound waterproofing issues.</p> <p>Notes:</p> <ol style="list-style-type: none"> 1. Parking is a major issue and the south side of the site is presumably a leasing arrangement with the western neighbor. Transportation uses this lot and should be relocated to alleviate the issue. Acquiring the south lot or formalizing the leasing arrangement is advised. 2. Add an asphalt bunker with a appropriate concrete apron at southern parcel 3. Provide covered area for a more weather-proof storage of wear plates and sheet metal

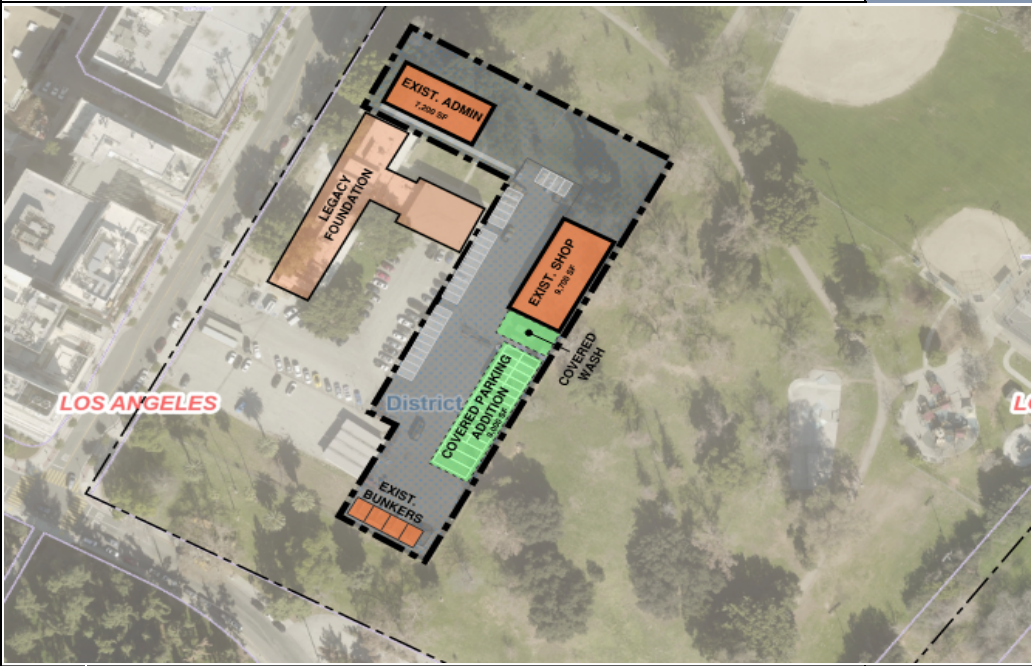
NAME	G3Y3 LINCOLN DISTRICT SERVICE YARD			
ADDRESS	1350 San Pablo Street			
MASTER PLAN

FUNDING	PRIORITY	DESCRIPTION	ESTIMATED COST	
PRIORITY SHORT TERM	1	Make accessible entrance into administrative building	\$5,069	
	2	Repair/replace paving and stormwater to prevent trip hazards and vehicle damage	\$1,380,756	
	3	IT improvements to site	\$72,152	
	4	HVAC upgrades to Administration and Shop buildings	\$414,129	
	5	Security upgrades to site--fencing, cameras, etc.	\$893,021	
	6	Repair plumbing waste systems shared between buildings	\$157,369	
LONG TERM	7	Addition of covered parking area and covered vehicle wash with clarifier	\$1,902,539	
MASTER PLAN NOTES	<p>Overview: The site is primarily occupied by Recreation and Parks (RAP) but also includes a separate building and parking for the Legacy Foundation.</p> <p>Notes: 1. Add covered parking structure to storage building to protect and secure vehicles and equipment from the weather and to prevent theft and vandalism 2. Add a covered rough wash and clarifier addition to storage building</p>

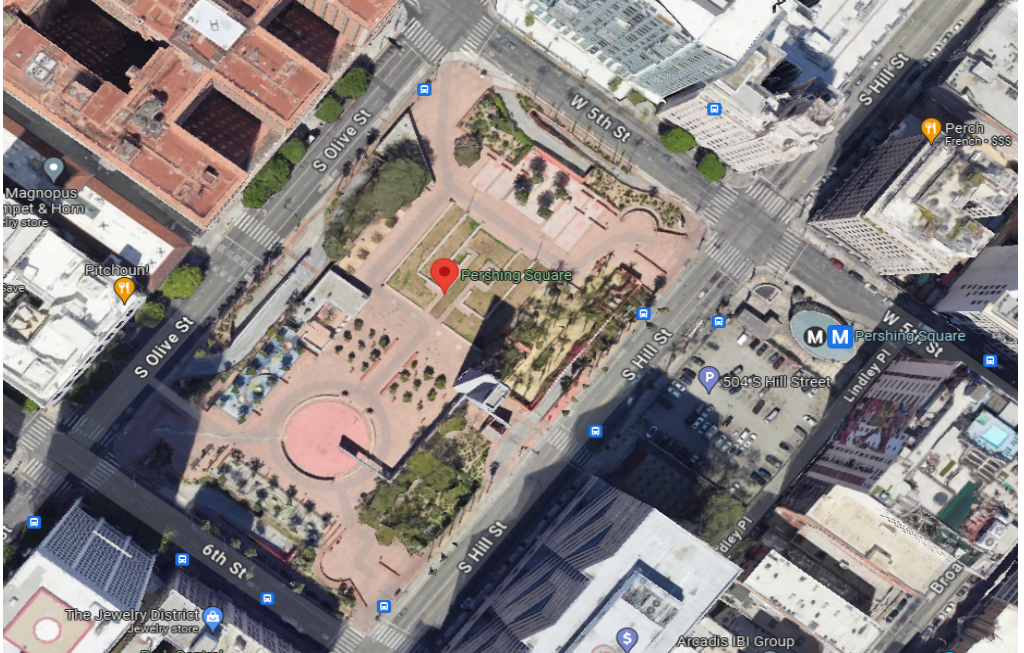
NAME	G3Y5 CIVIC CENTER DISTRICT SERVICE YARD			
ADDRESS	200 North Spring Street			
MASTER PLAN

FUNDING	PRIORITY	DESCRIPTION	ESTIMATED COST	
PRIORITY SHORT TERM	1	Provide storage shelving/racking to improve efficiency	\$13,758	
LONG TERM	2	Finish work space to create better work environment at Pershing Square	\$258,004	
MASTER PLAN NOTES	<p>Overview: The work areas for this yard are divided between Civic Center and nearby Pershing Square. The Civic Center spaces are primarily for storage of equipment and some supplies as well as office space. Pershing Square includes break areas, lockers, equipment storage, and material storage areas. None of the Pershing Square spaces are finished areas. Finishing these spaces will provide a better work environment and more efficient use of these areas.</p>

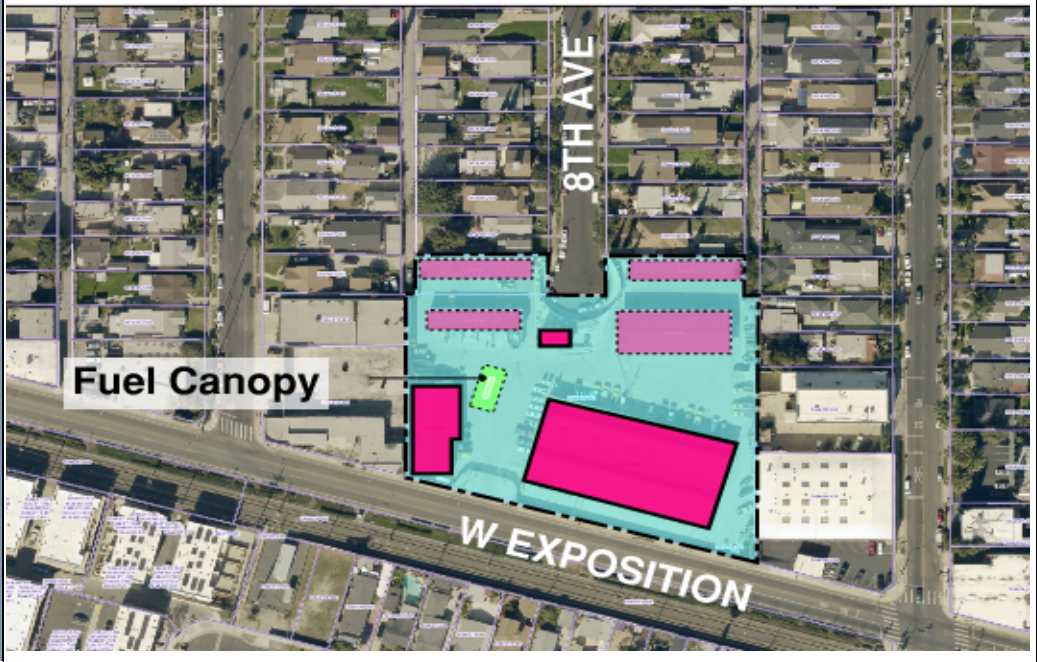
NAME	G2Y3 WESTERN YARD			
ADDRESS	2801 Exposition Boulevard			
MASTER PLAN

FUNDING	PRIORITY	DESCRIPTION	ESTIMATED COST	
PRIORITY SHORT TERM	1	Update lighting electrical systems in Building G	\$830,650	
	2	Envelope improvements to Building G	\$391,743	
	3	New HVAC systems for Building G	\$1,427,679	
LONG TERM	4	Provide covered fuel canopy	\$154,915	
MASTER PLAN NOTES	<p>Overview: The site occupied by LADOT's Field Operations. GSD is scheduled to move into part of the warehouse space in the near future.</p> <p>Notes: 1. Building's are older and Building G, which contains most of the regularly occupied spaces, needs HVAC, electrical/lighting, and envelope upgrades. 2. A fuel Canopy is also needed to cover the fueling positions.</p>

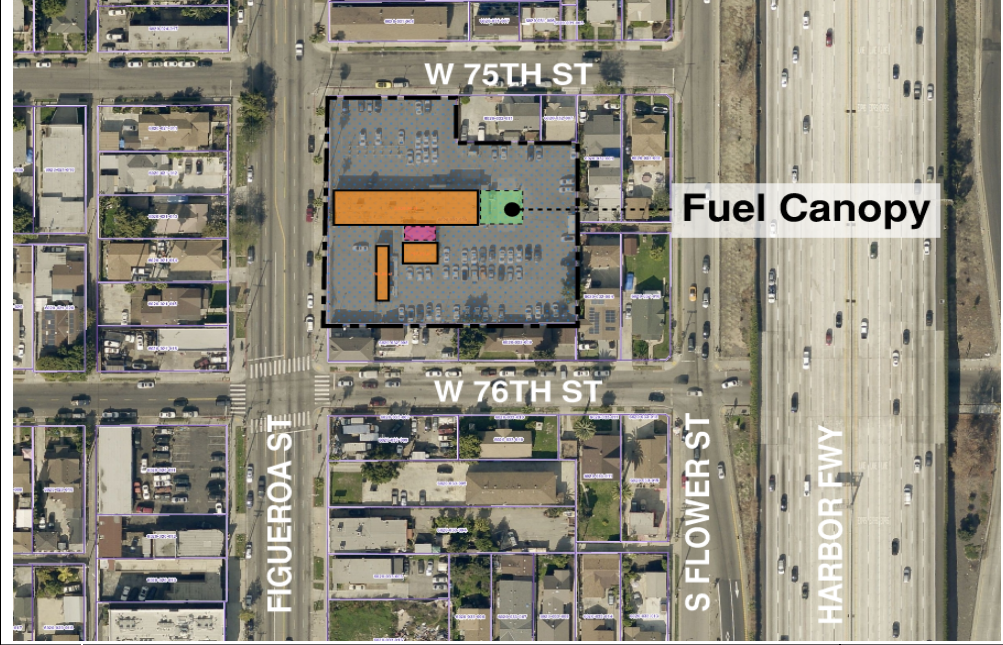
NAME	G2Y10 PARKING ENFORCEMENT-SOUTHERN YARD			
ADDRESS	7510 South Figueroa Street			
MASTER PLAN

FUNDING	PRIORITY	DESCRIPTION	ESTIMATED COST	
PRIORITY SHORT TERM	1	Verify and abate (if required) presence of asbestos	\$79,536	
	2	Provide security upgrades to site--e.g. perimeter fencing, alarms, cameras	\$777,642	
	3	Improve vehicle charging infrastructure	\$42,398	
	4	Update plumbing infrastructure	\$53,099	
	5	Update electrical infrastructure campus-wide	\$1,089,262	
	6	Repair leaking roof	\$142,036	
	7	Repair pavement	\$215,624	
LONG TERM	8	Add covered fuel canopy	\$154,915	
	9	Renovate Maintenance Shop Restrooms	\$113,086	
MASTER PLAN NOTES	<p>Overview: The site includes workspaces for LADOT and a maintenance garage run by GSD.</p> <p>Notes:</p> <ol style="list-style-type: none"> 1. Visual inspection of spaces seems to indicate the presence of asbestos but further testing is required 2. New vandal resistant fencing, building alarms, and security cameras site wide. 3. Charging infrastructure is make-shift, at capacity, and unsafe. 4. Plumbing improvements are recommended to address staff concerns. 5. Existing electrical infrastructure appears to be at capacity. 6. Spot repair of roof leaks and perimeter coping 7. Resurfacing pavement is recommended for long term durability and to prevent trip hazards. 8. Adding a fuel canopy over existing fuel area is recommended to prevent stormwater contamination. 9. Renovate restrooms for equal and appropriate facilities for men and women.

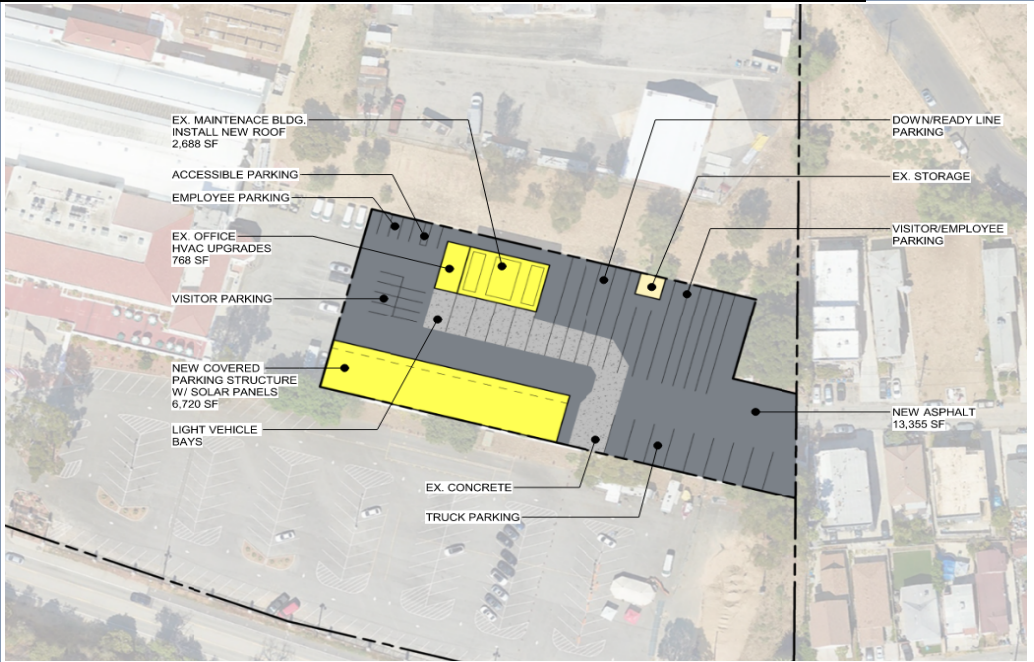
MASTER PLAN

FUNDING	PRIORITY	DESCRIPTION	ESTIMATED COST
PRIORITY SHORT TERM	1	Security Improvements	\$551,257
	2	Repair Roof Leaks	\$54,211
	3	Upgrades to HVAC systems to provide better conditioning/tempering	\$26,581
	4	Reconstruction of apparatus storage building	\$3,015,562
LONG TERM	5	Long term consolidation with Fire Station #401	See G1Y2

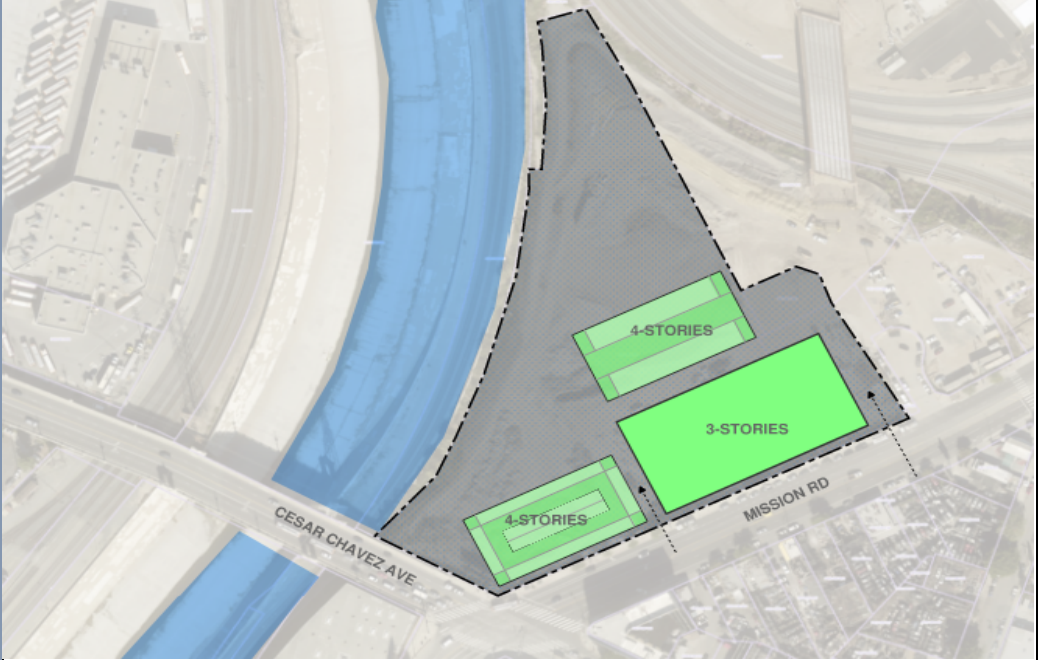
NAME	G1Y10 PIPER TECH: MOBILE COMMAND RESPONSE UNIT (MCRU-LAPD)		
ADDRESS	555 Ramirez Street		
MASTER PLAN

FUNDING	PRIORITY	DESCRIPTION	ESTIMATED COST
PRIORITY SHORT TERM	1	Shop lighting upgrades	\$54,079
LONG TERM	2	Site relocation to 525 North Mission Road	\$192,320,910
MASTER PLAN NOTES	<p>Overview: LAPD's Mobile Command Response Unit (MCRU) is located on the second level at Piper Tech. Many of the space are ad hoc and some of the shop/storage spaces are congested due to lack of space. Short term improvements focus on lighting upgrades in the shop/storage areas while long term improvements involve relocation to a new site.</p> <p><i>Note: Short term improvements would be redundant if a long term relocation is pursued.</i></p>

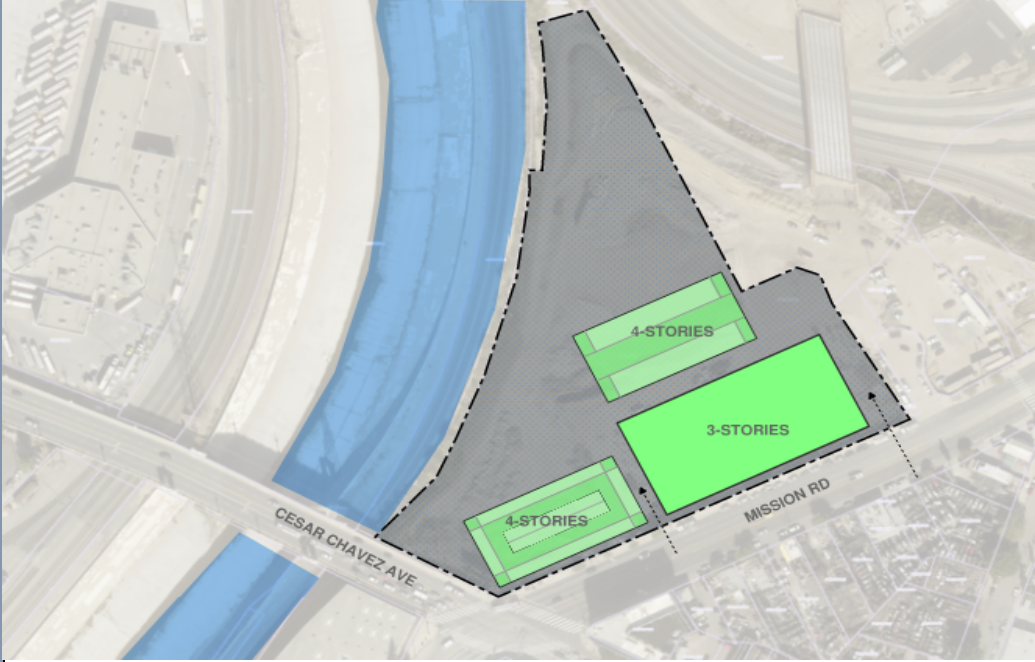
NAME	G1Y10 PIPER TECH: EVIDENCE AND PROPERTY MANAGEMENT DIV (EPMD)			
ADDRESS	555 Ramirez Street			
MASTER PLAN

FUNDING	PRIORITY	DESCRIPTION	ESTIMATED COST
PRIORITY SHORT TERM	1	Fire/Life Safety Improvements to chemical storage room	\$35,834	
	2	Construct locker/changing rooms	\$53,091	
	3	HVAC improvements to storage areas	\$8,653	
	4	Condensate line insulation	\$692	
LONG TERM	5	Relocation to a new site at 525 North Mission Road	\$192,320,910	
MASTER PLAN NOTES	<p>Overview: EPMD occupies a roughly 20,000 SF suite on the second floor of Piper Tech. While spaces are generally adequate some fire/life safety improvements and systems upgrades are recommended. Due to space limitations at Piper Tech long term relocation is advised.</p>			
	<p>Note: Short term improvements would be redundant to a long term relocation.</p>

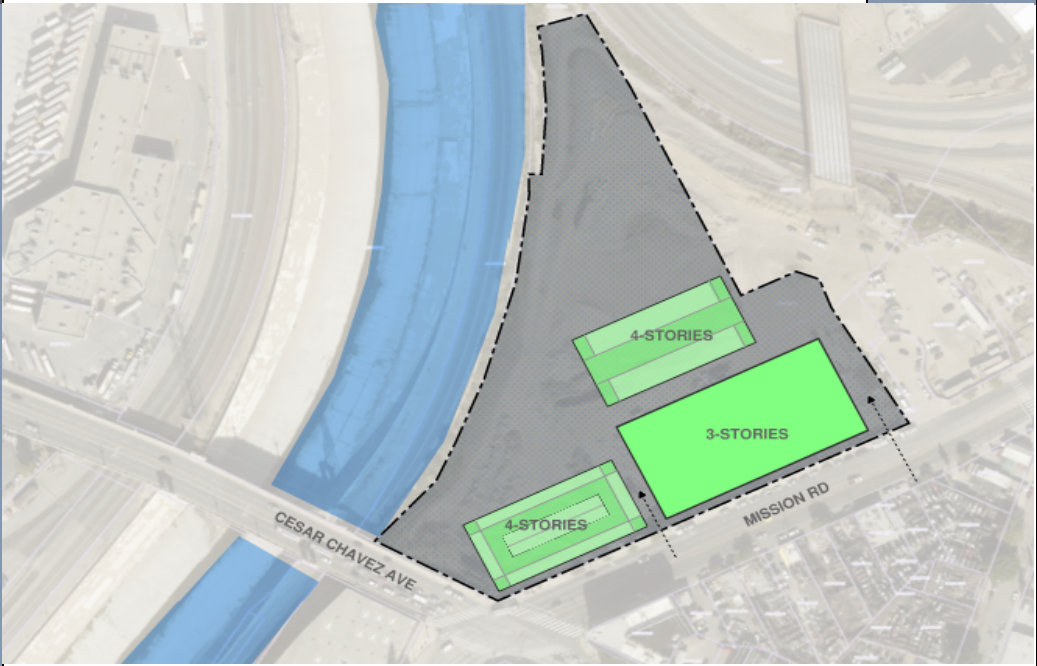
NAME	G1Y10 PIPER TECH: INFORMATION TECHNOLOGY BUREAU (LAPD-ITB)			
ADDRESS	555 Ramirez Street			
MASTER PLAN

FUNDING	PRIORITY	DESCRIPTION	ESTIMATED COST	
PRIORITY SHORT TERM	1	Add exit to rear caged area	\$13,610	
	2	Rework sprinkler heads	\$20,766	
	3	Add eyewash to battery charging area	\$7,268	
	4	Add interior cameras	\$195,549	
	5	Provide climate controlled office	\$31,563	
LONG TERM	6	Relocation to new site at 525 North Mission Road	\$192,320,910	
MASTER PLAN NOTES	<p>Overview: ITB occupies a largely makeshift area on the second floor of Piper Tech. Ad hoc improvements have created several life safety issues. No climate control is present for regularly occupied work spaces and no interior cameras are present for security and liability.</p> <p><i>Note: Short term improvements would be redundant to a long term relocation.</i></p>
