STRUCTURAL EVALUATION OF THE JAMES K. HAHN CITY HALL EAST BUILDING

Subject: **STRUCTURAL EVALUATION OF THE JAMES K. HAHN CITY HALL EAST-
200 N. MAIN ST. W.O. EXX01002**

INTRODUCTION

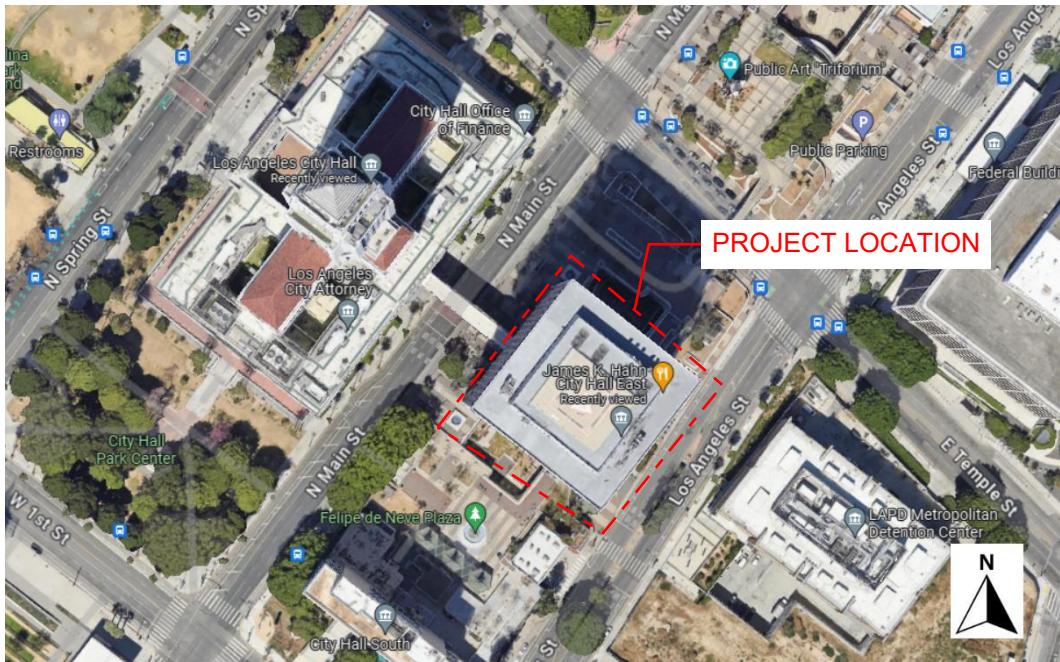
Photo 1: Site Plan

On June 25th, 2024, Structural Engineering Division (SED) staff accompanied City Hall East (CHE) building maintenance staff to perform a site visit for The James K. Hahn City Hall East located at 200 N. Main St, Los Angeles, CA 90012 (Photos 1 and 2). The purpose of the site visit was to perform a visual inspection of the reported deterioration in building columns (A to G) located on southwest side of the building adjacent to the planter area and open court. (Photos 3, 4 and 5).
